BREAKWATER LOCATION
U. S. NAVAL AIR STATION, ALAMEDA, CALIFORNIA

MODEL INVESTIGATION

TECHNICAL MEMORANDUM NO. 2-242

DECEMBER 1947

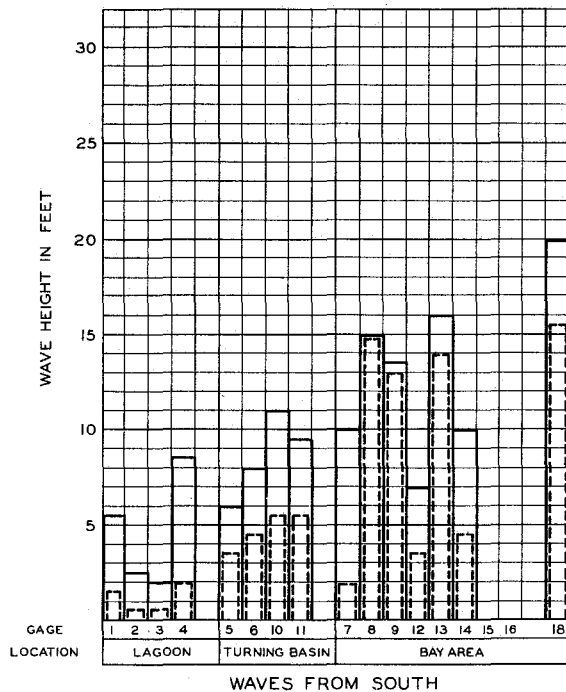
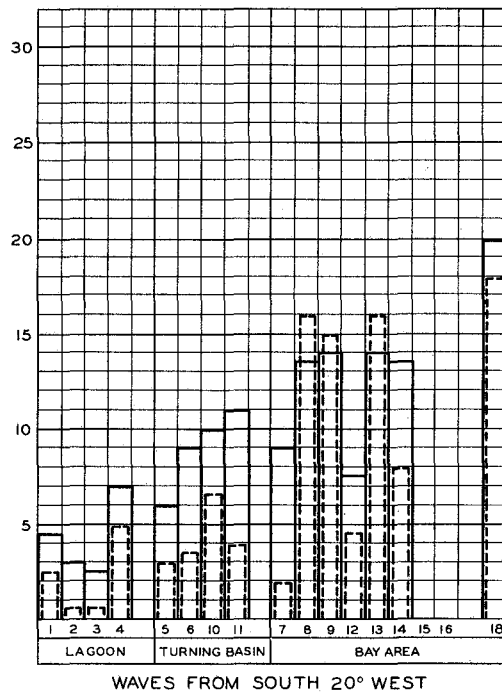
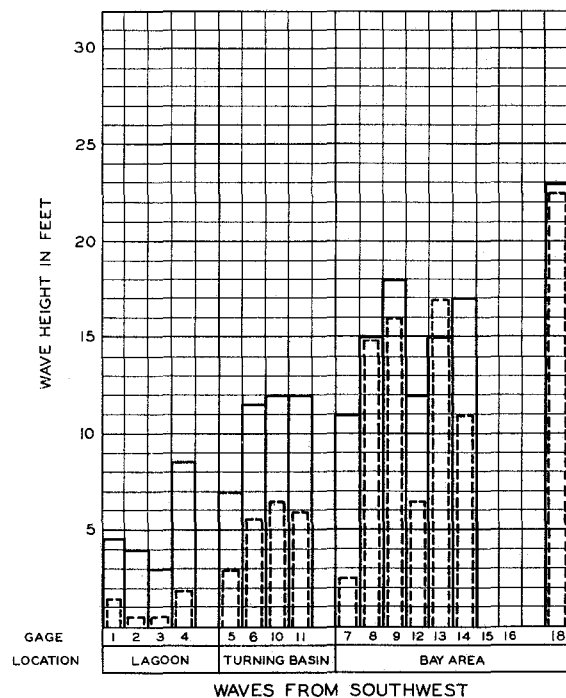
MODEL STUDY OF BREAKWATER LOCATION
U.S. NAVAL AIR STATION
ALAMEDA, CALIFORNIA

COMPARISON OF WAVE HEIGHTS
BASE TEST AND PLAN 6

NOTE: TOP ELEVATION OF BREAKWATER IS +17.0 FEET, MEAN LOWER LOW WATER.

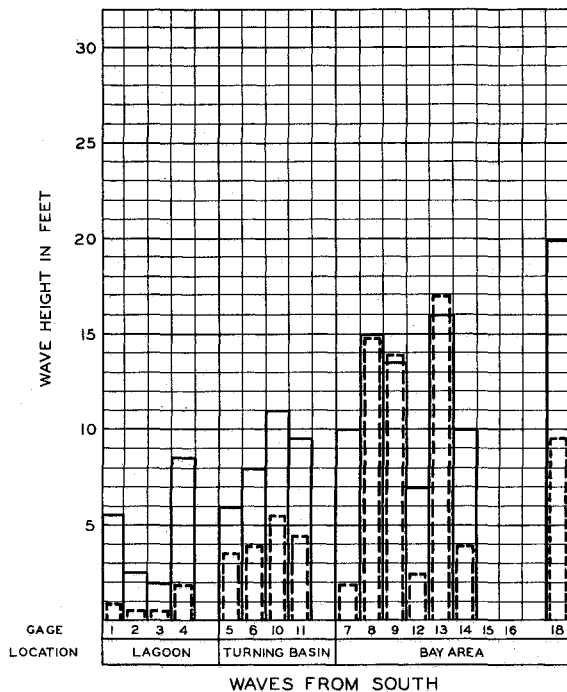
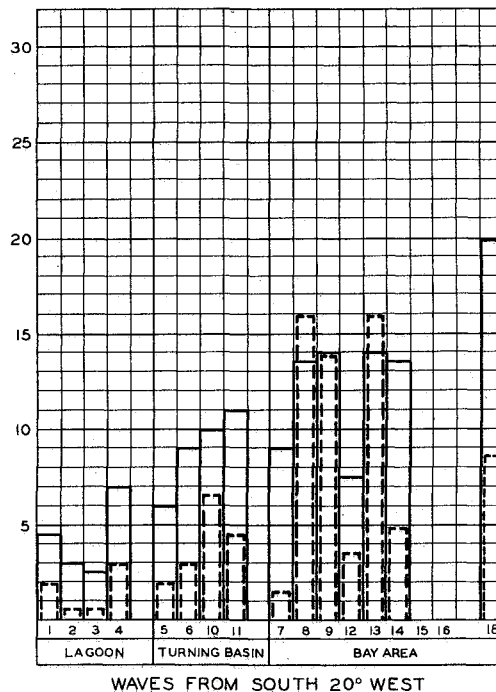
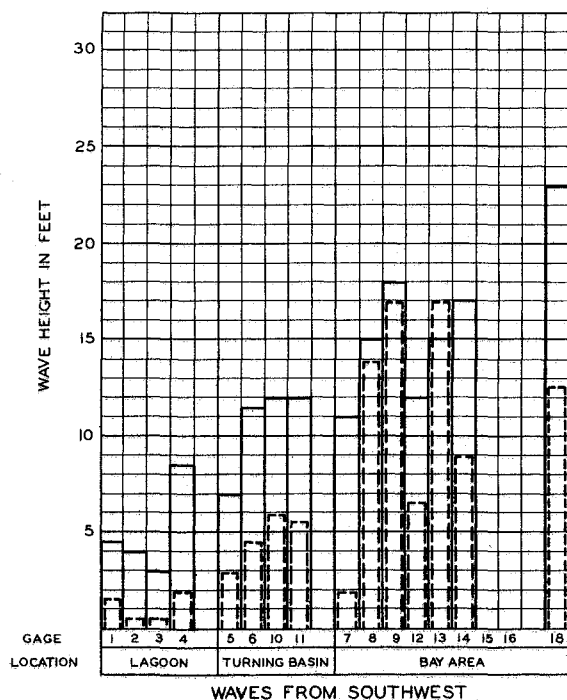
MODEL STUDY OF BREAKWATER LOCATION
U.S. NAVAL AIR STATION
ALAMEDA, CALIFORNIA

COMPARISON OF WAVE HEIGHTS
BASE TEST AND PLAN 7

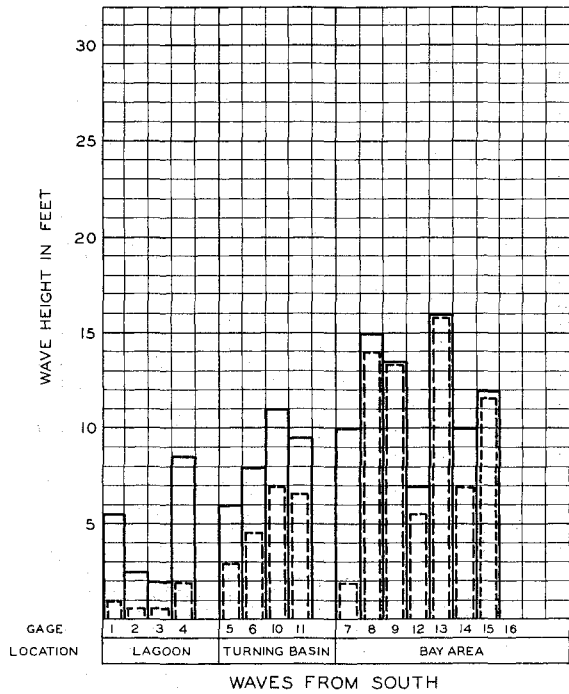
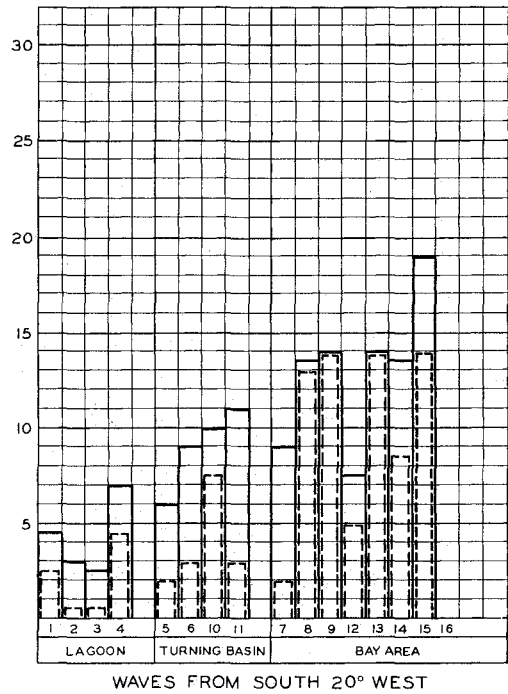
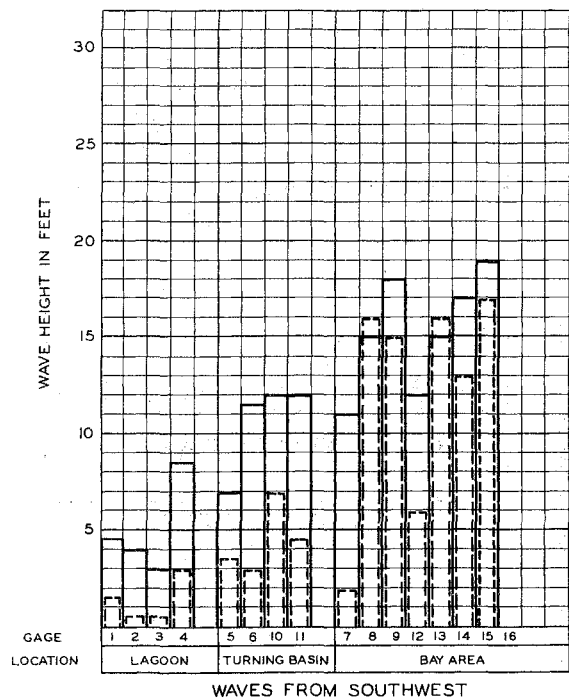
MODEL STUDY OF BREAKWATER LOCATION
U.S. NAVAL AIR STATION
ALAMEDA, CALIFORNIA

COMPARISON OF WAVE HEIGHTS

BASE TEST AND PLAN 8

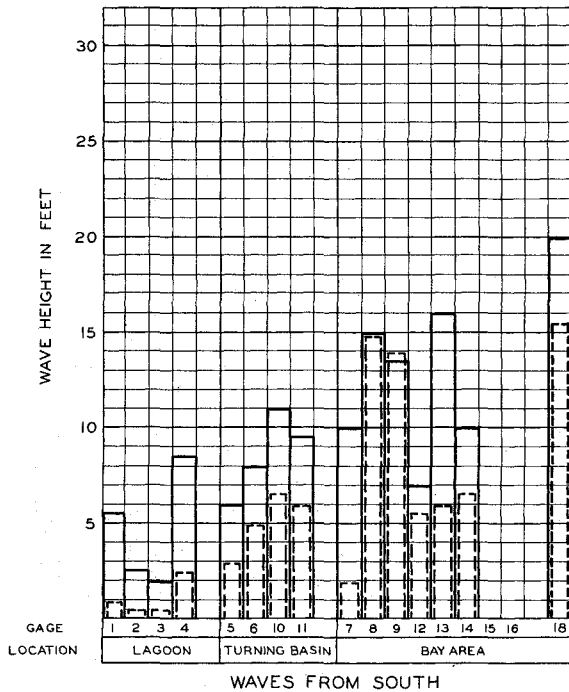
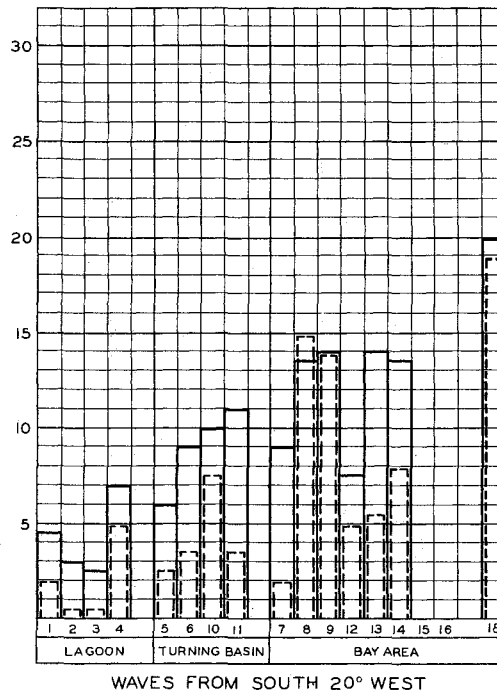
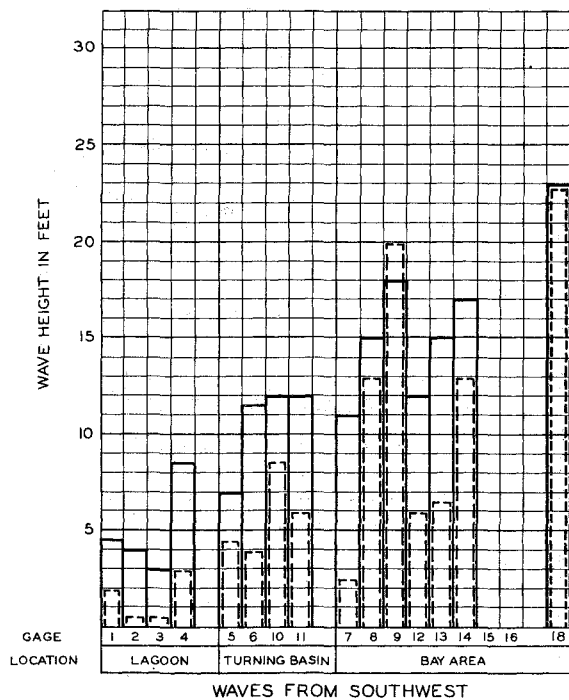
MODEL STUDY OF BREAKWATER LOCATION
U.S. NAVAL AIR STATION
ALAMEDA, CALIFORNIA

COMPARISON OF WAVE HEIGHTS
BASE TEST AND PLAN 9

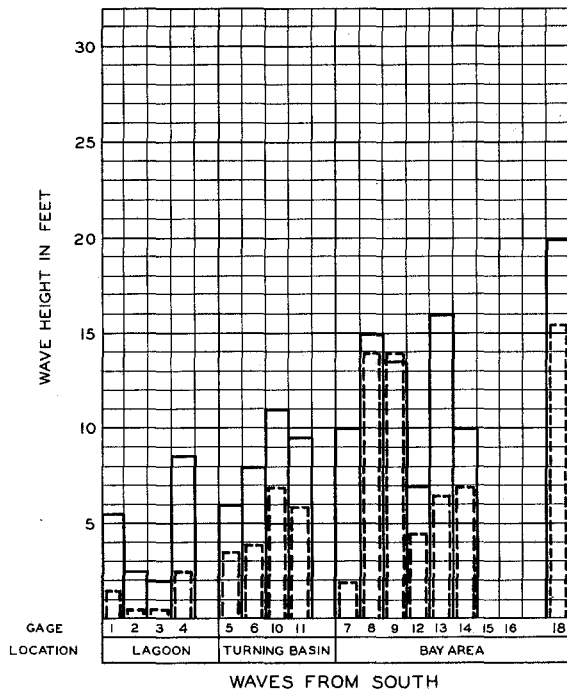
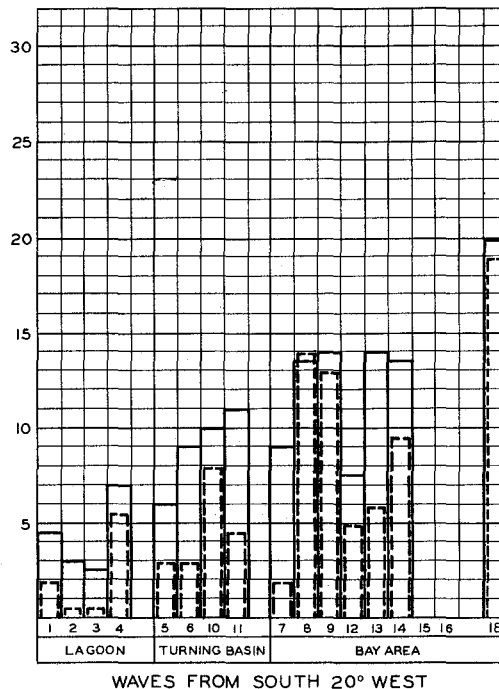
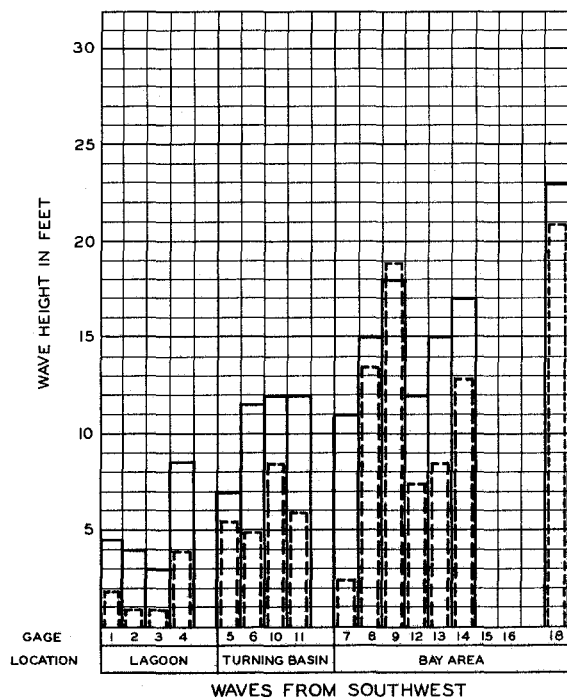
MODEL STUDY OF BREAKWATER LOCATION
U.S. NAVAL AIR STATION
ALAMEDA, CALIFORNIA

COMPARISON OF WAVE HEIGHTS
BASE TEST AND PLAN 10

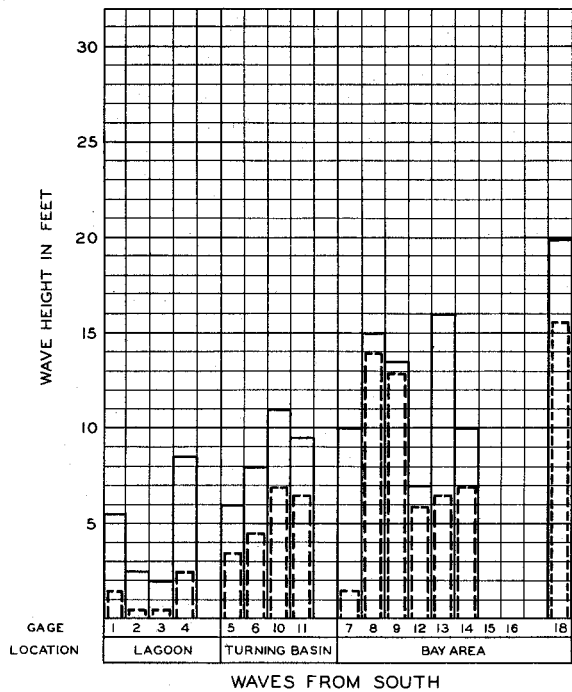
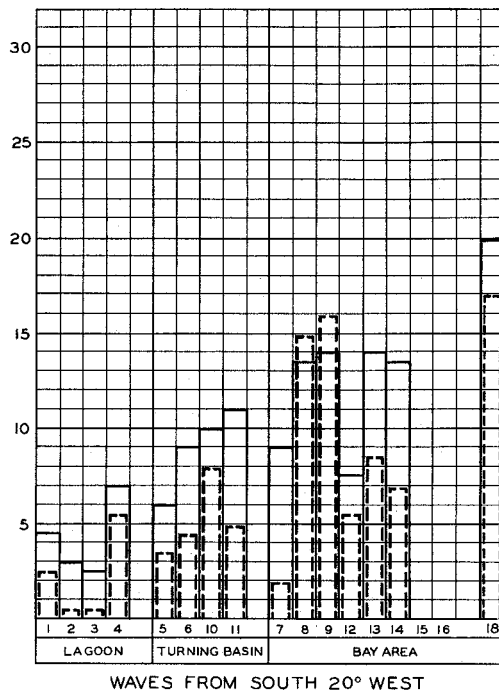
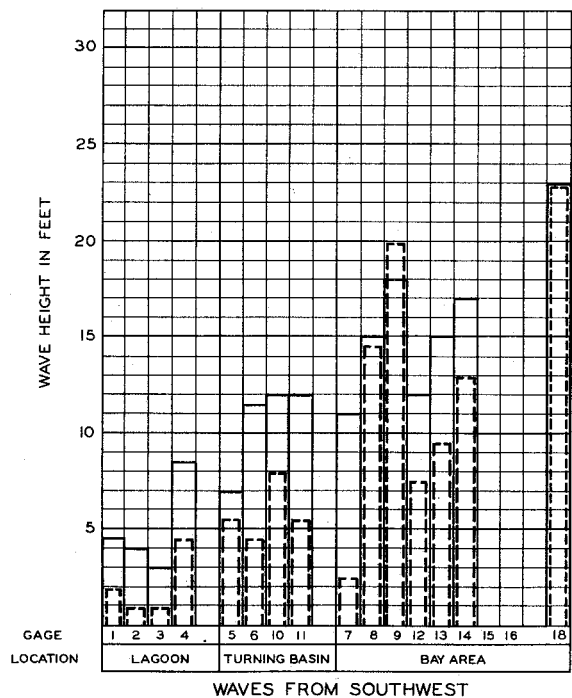
MODEL STUDY OF BREAKWATER LOCATION
U. S. NAVAL AIR STATION
ALAMEDA, CALIFORNIA

COMPARISON OF WAVE HEIGHTS
BASE TEST AND PLAN II

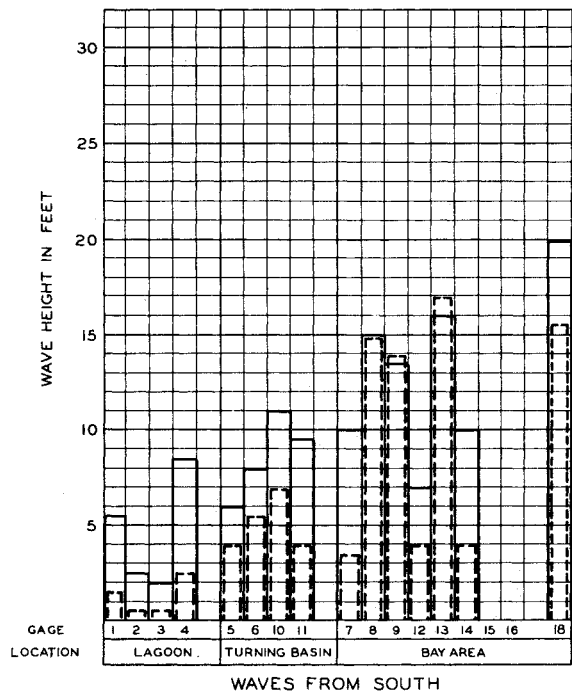
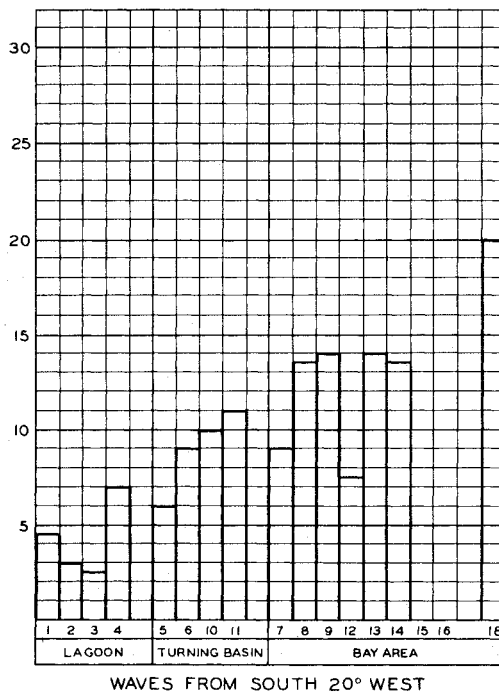
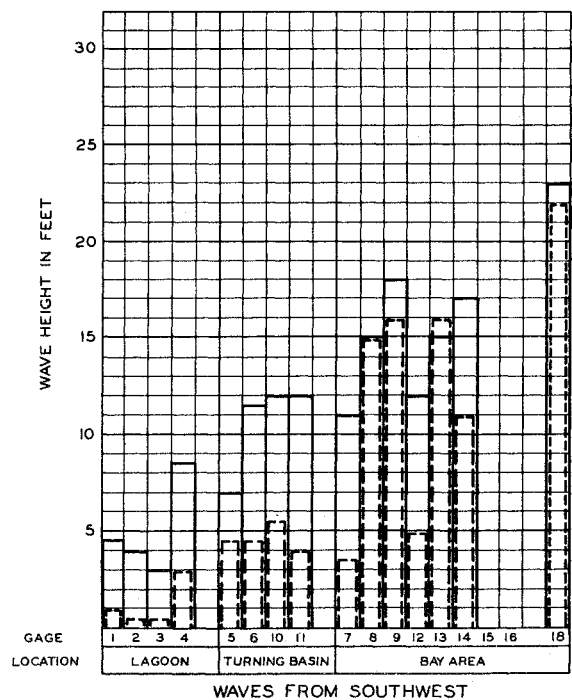
MODEL STUDY OF BREAKWATER LOCATION
U.S. NAVAL AIR STATION
ALAMEDA, CALIFORNIA

COMPARISON OF WAVE HEIGHTS
BASE TEST AND PLAN 12

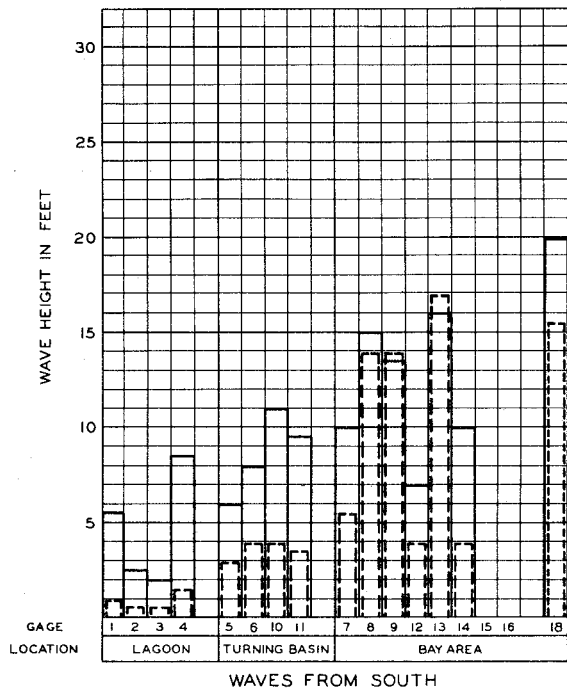
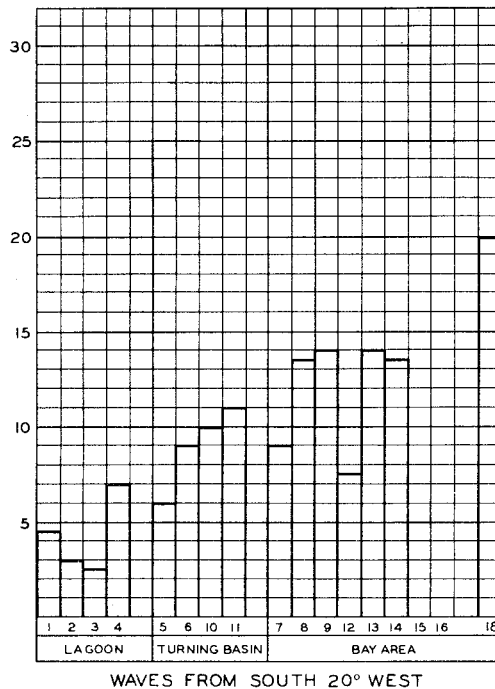
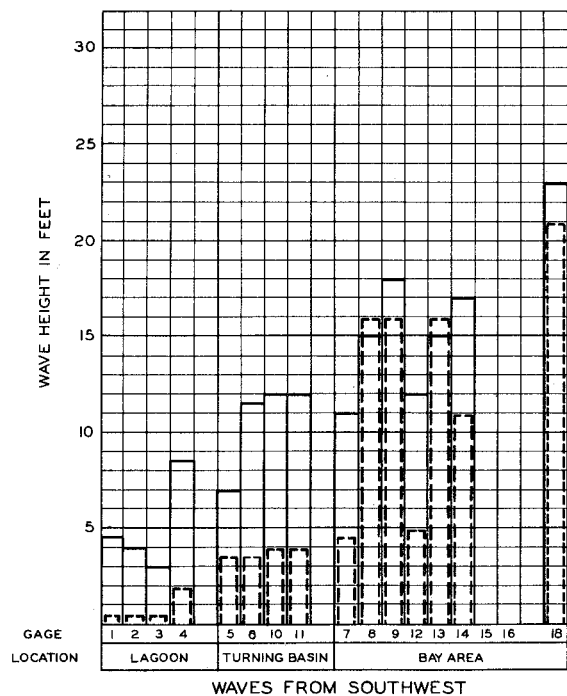
MODEL STUDY OF BREAKWATER LOCATION
U.S. NAVAL AIR STATION
ALAMEDA, CALIFORNIA

COMPARISON OF WAVE HEIGHTS

BASE TEST AND PLAN 13

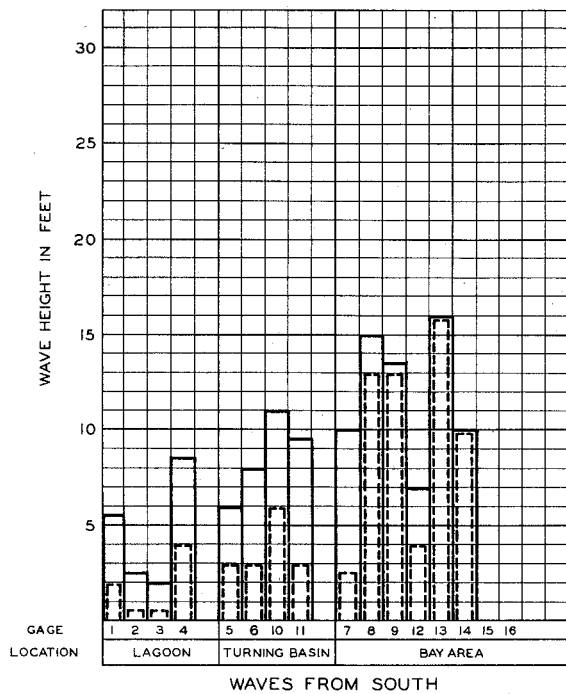
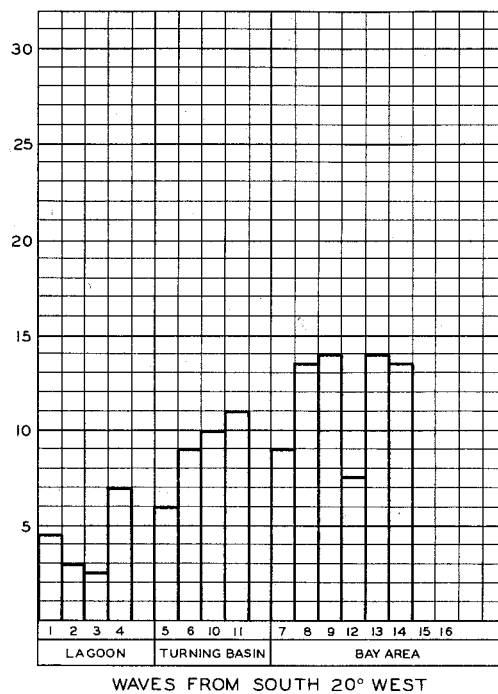
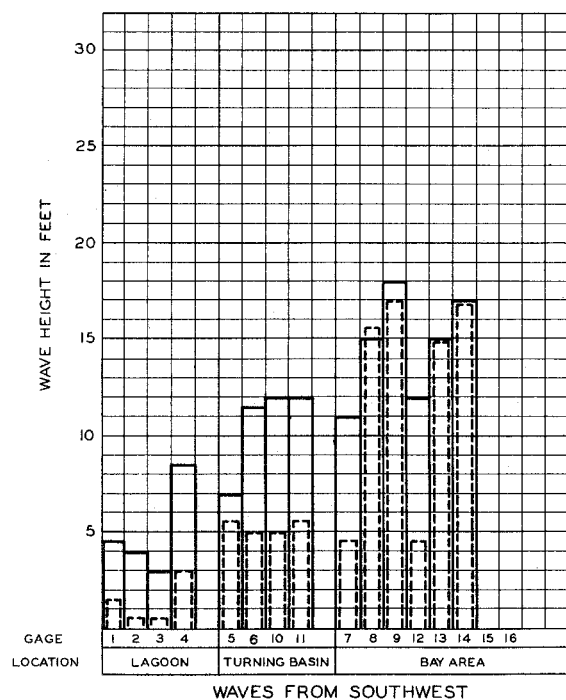
MODEL STUDY OF BREAKWATER LOCATION
U. S. NAVAL AIR STATION
ALAMEDA, CALIFORNIA

COMPARISON OF WAVE HEIGHTS
BASE TEST AND PLAN 14

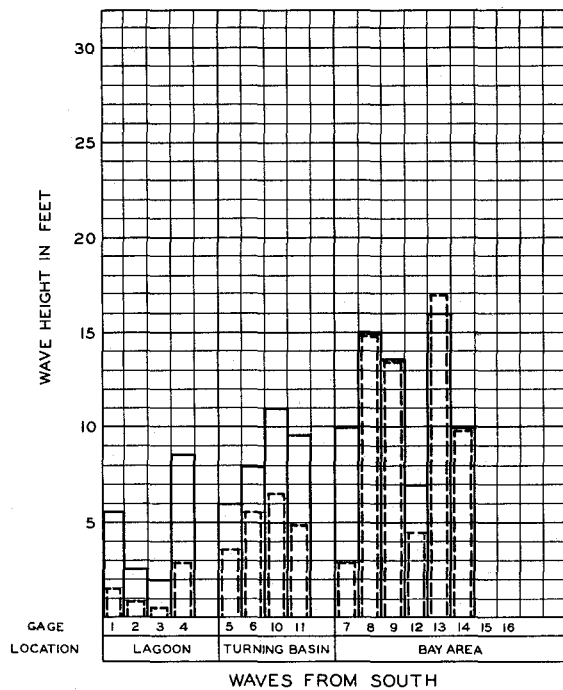
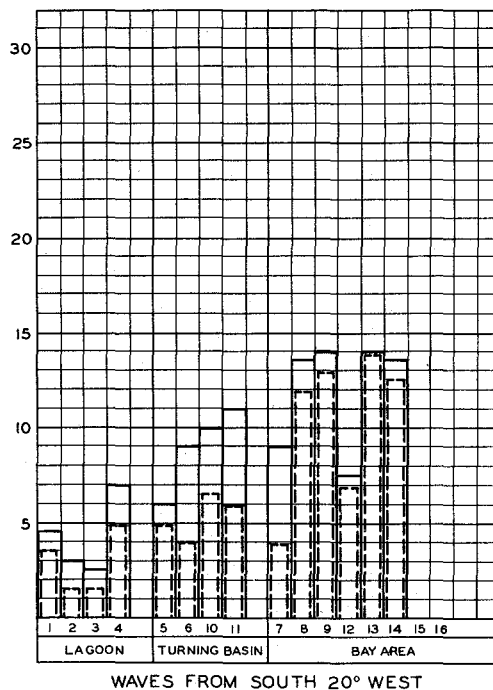
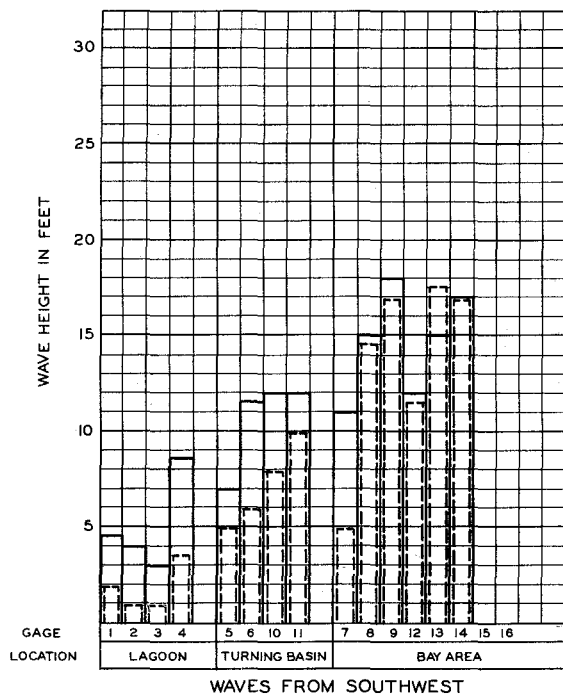
MODEL STUDY OF BREAKWATER LOCATION
U.S. NAVAL AIR STATION
ALAMEDA, CALIFORNIA

COMPARISON OF WAVE HEIGHTS
BASE TEST AND PLAN 15

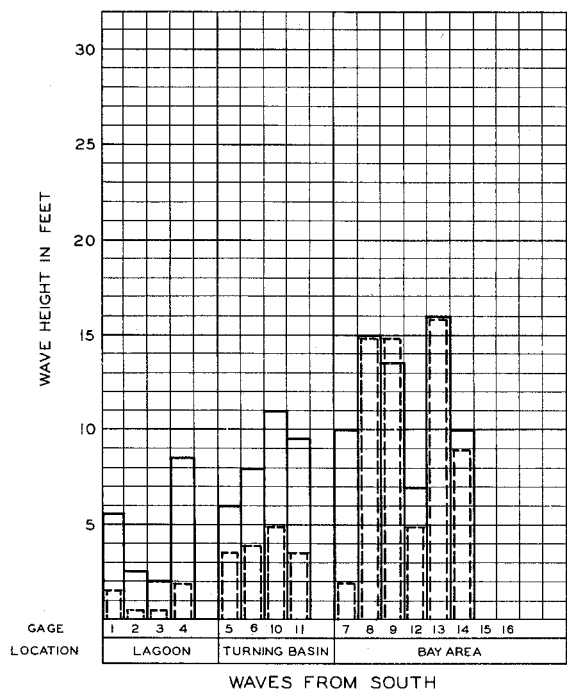
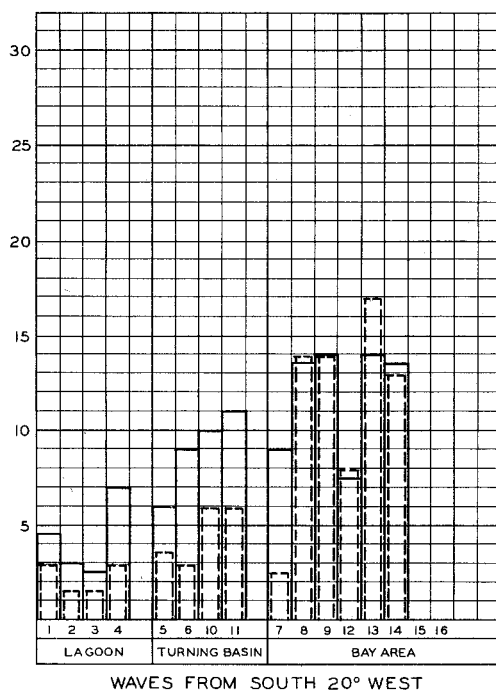
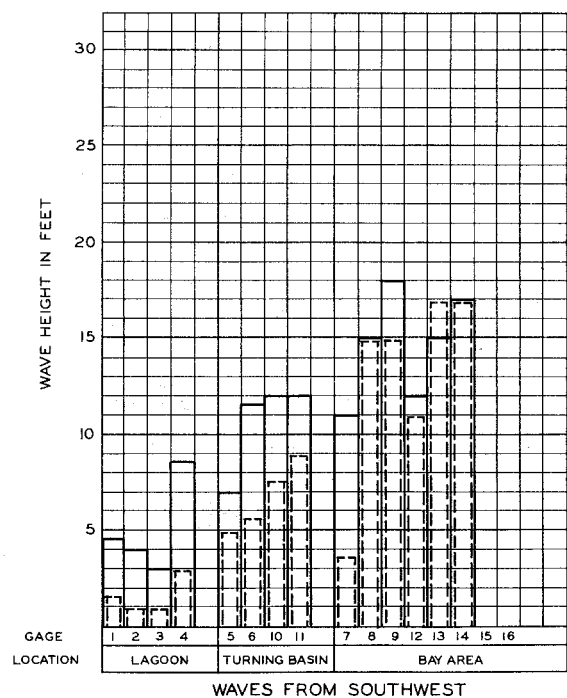
MODEL STUDY OF BREAKWATER LOCATION
U. S. NAVAL AIR STATION
ALAMEDA, CALIFORNIA

COMPARISON OF WAVE HEIGHTS
BASE TEST AND PLAN 17C

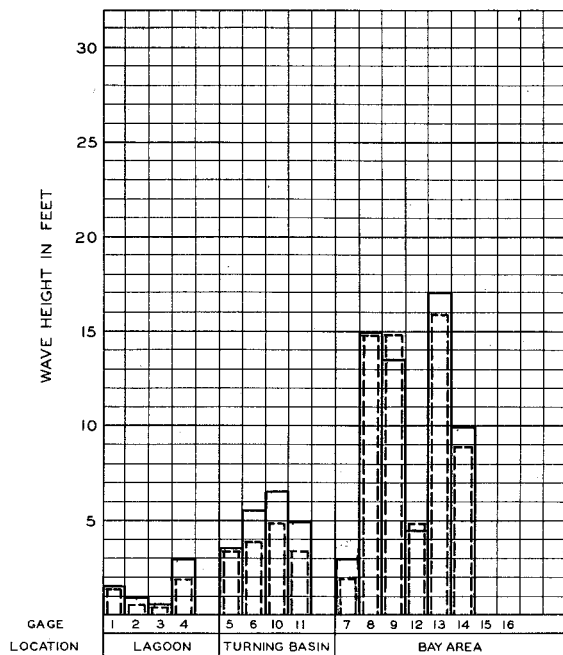
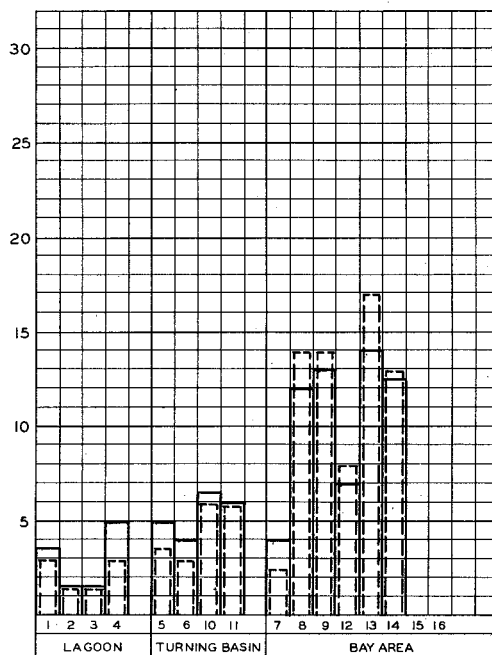
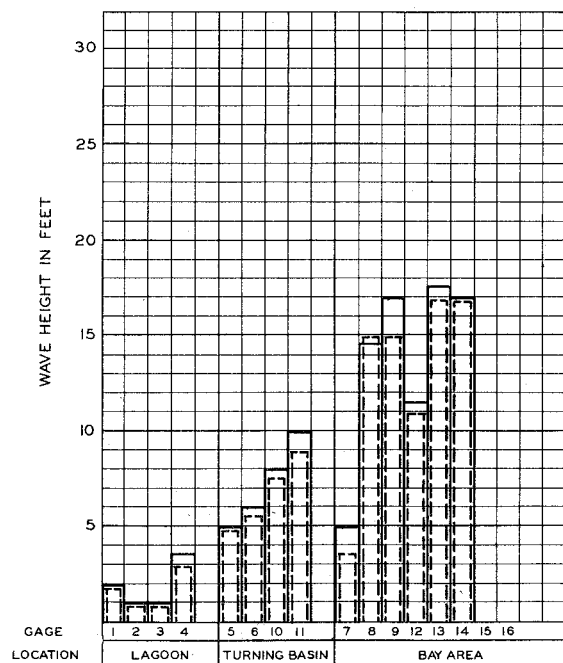
MODEL STUDY OF BREAKWATER LOCATION
U. S. NAVAL AIR STATION
ALAMEDA, CALIFORNIA

COMPARISON OF WAVE HEIGHTS
BASE TEST AND PLAN 18B

WAVES FROM SOUTH

WAVES FROM SOUTH 20° WEST

WAVES FROM SOUTHWEST

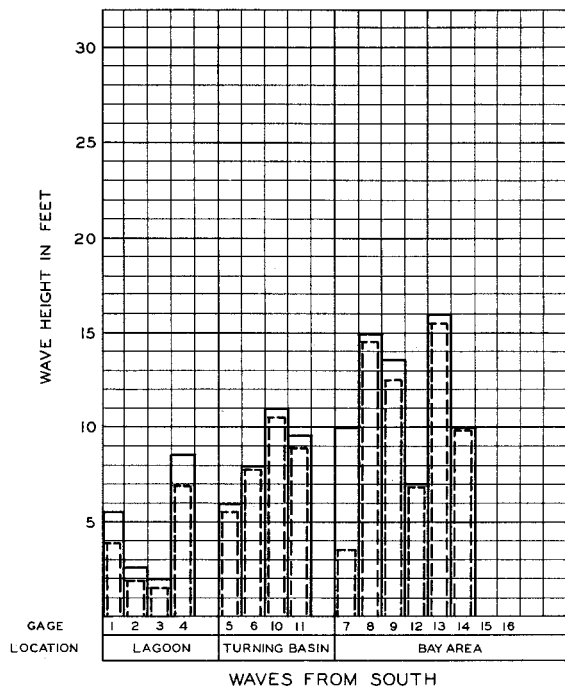
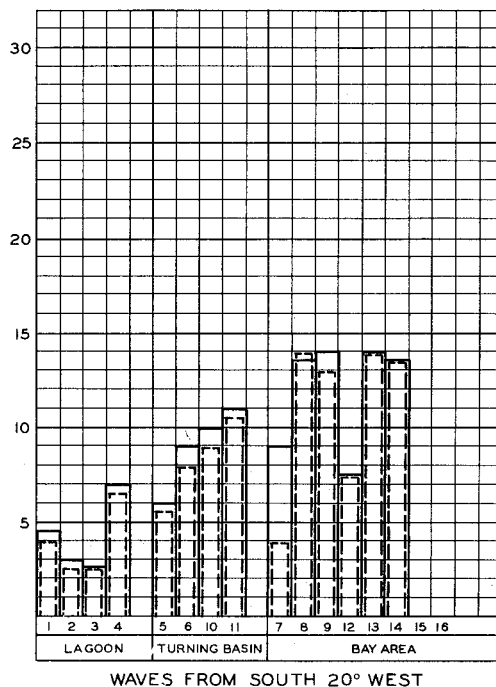
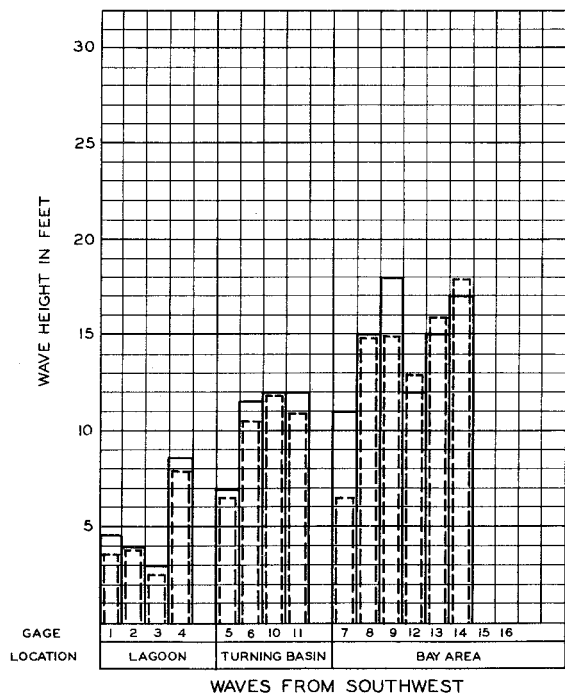
MODEL STUDY OF BREAKWATER LOCATION
U.S. NAVAL AIR STATION
ALAMEDA, CALIFORNIA
COMPARISON OF WAVE HEIGHTS
PLAN 17C AND PLAN 18B

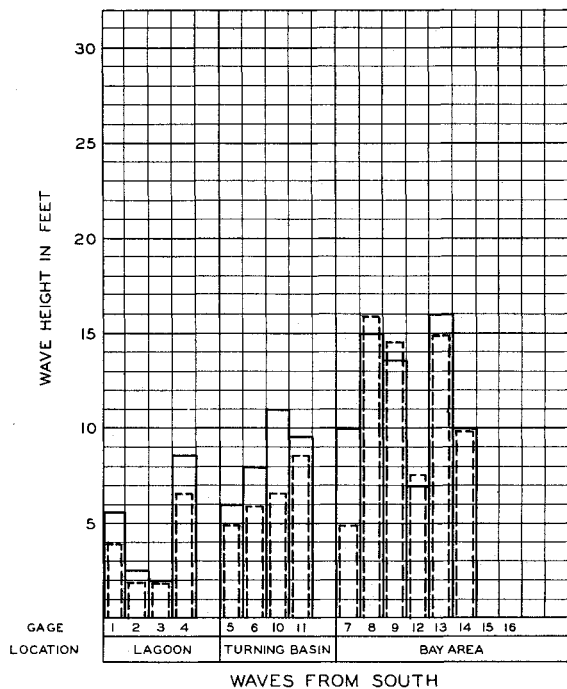
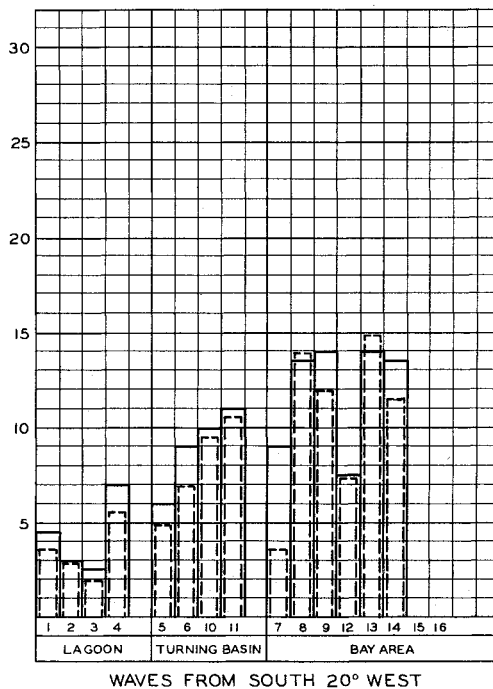
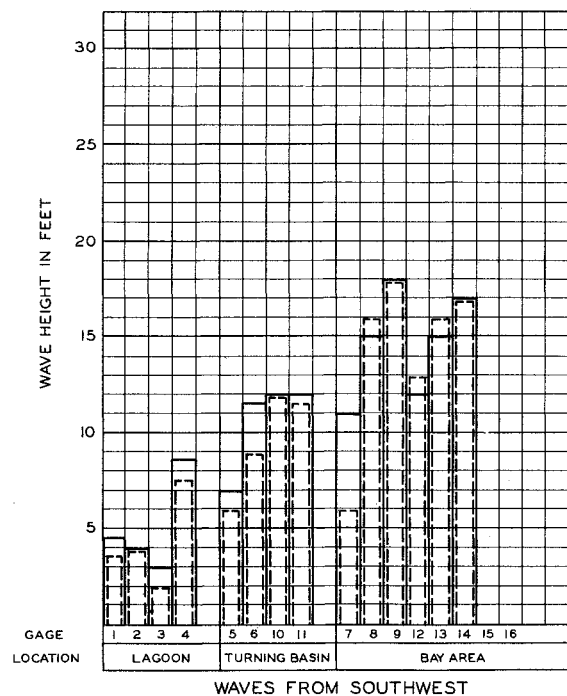
MODEL STUDY OF BREAKWATER LOCATION
U. S. NAVAL AIR STATION
ALAMEDA, CALIFORNIA

COMPARISON OF WAVE HEIGHTS
BASE TEST AND PLAN 19

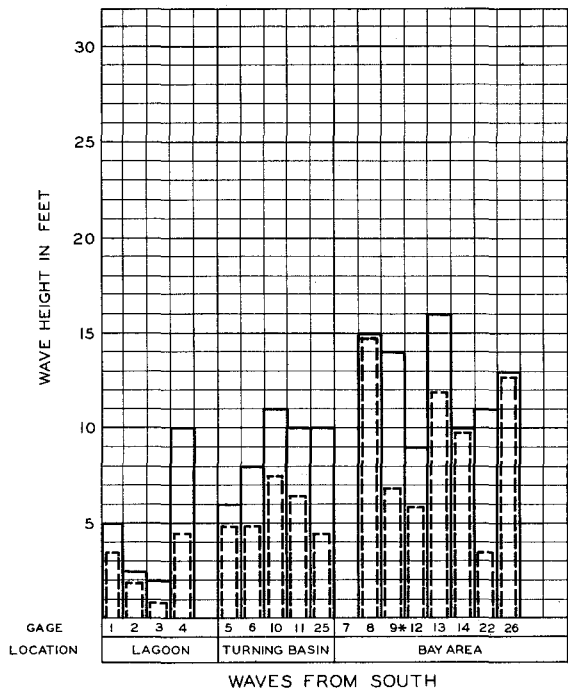
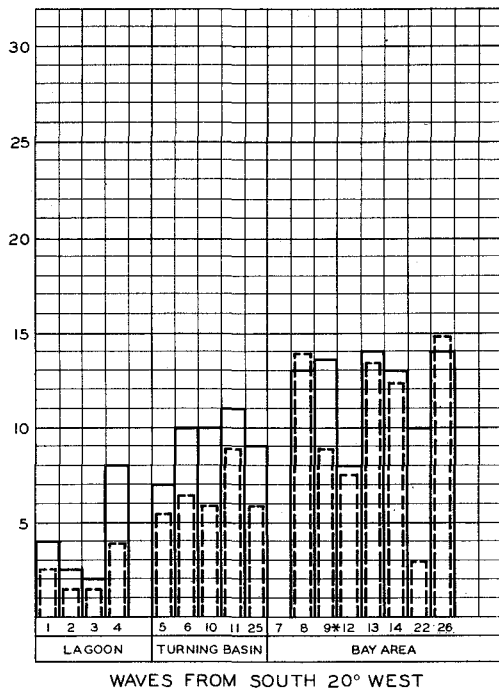
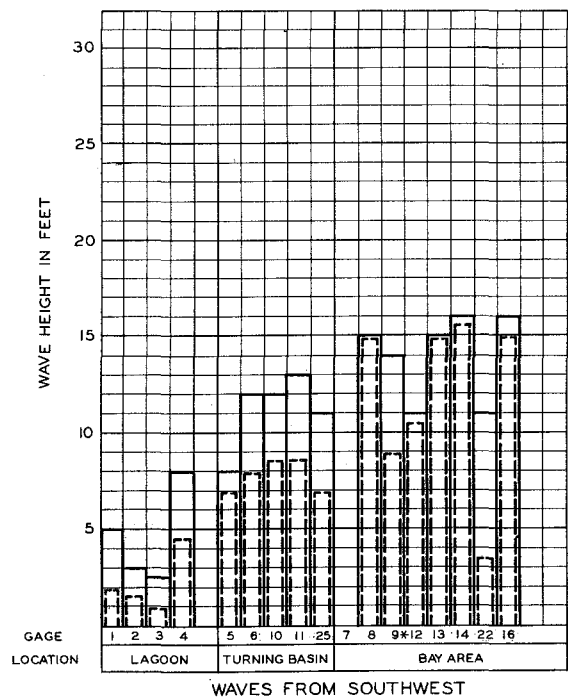
MODEL STUDY OF BREAKWATER LOCATION
U. S. NAVAL AIR STATION
ALAMEDA, CALIFORNIA

COMPARISON OF WAVE HEIGHTS
BASE TEST AND PLAN 20

TEST CONDITIONS

WAVE HEIGHT IN PROBLEM AREA APPROXIMATELY 10 FEET
WATER-SURFACE ELEVATION +9.6 FEET MLLW

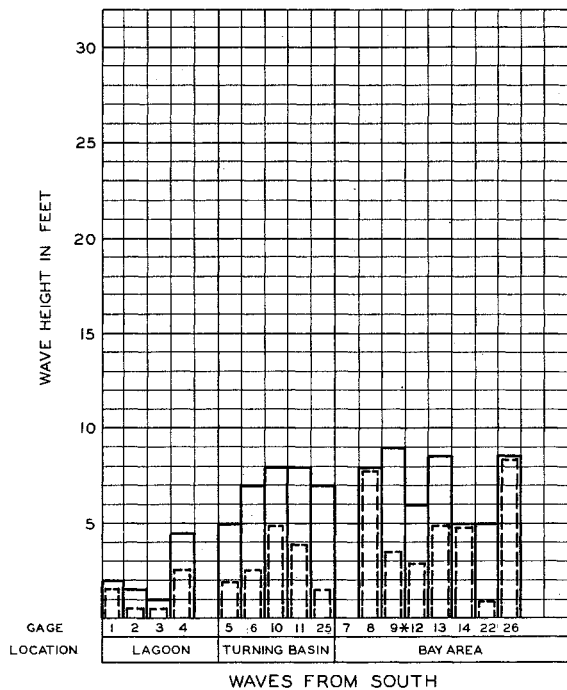
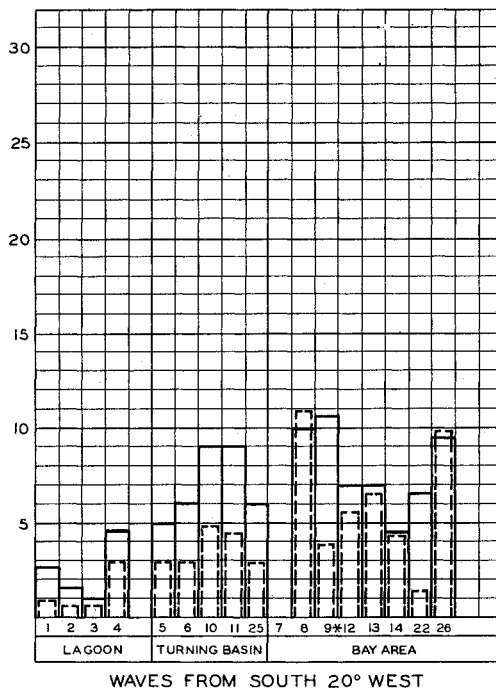
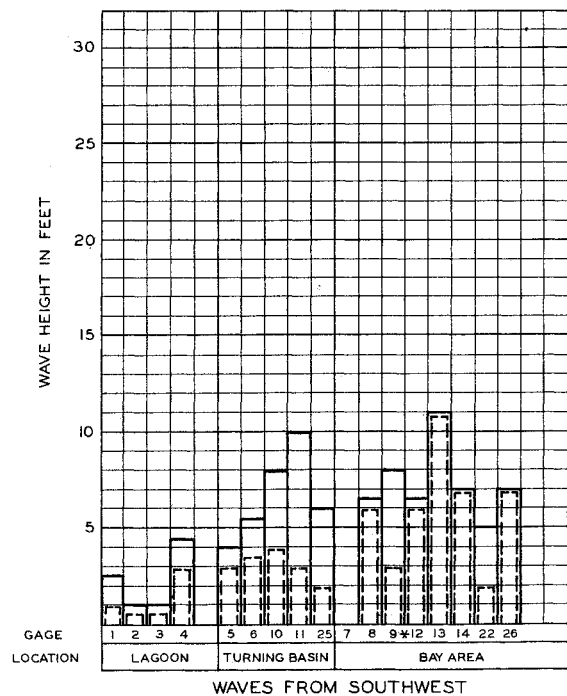
MODEL STUDY OF BREAKWATER LOCATION U.S. NAVAL AIR STATION ALAMEDA, CALIFORNIA

COMPARISON OF WAVE HEIGHTS BASE TEST AND PLAN 22

TEST CONDITIONS

WAVE HEIGHT IN PROBLEM AREA APPROXIMATELY 7 FEET.
WATER-SURFACE ELEVATION +7.0 FEET MLLW

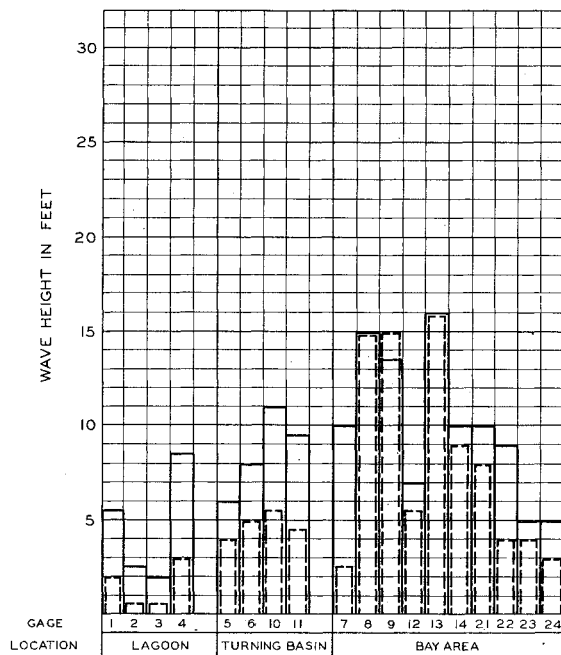
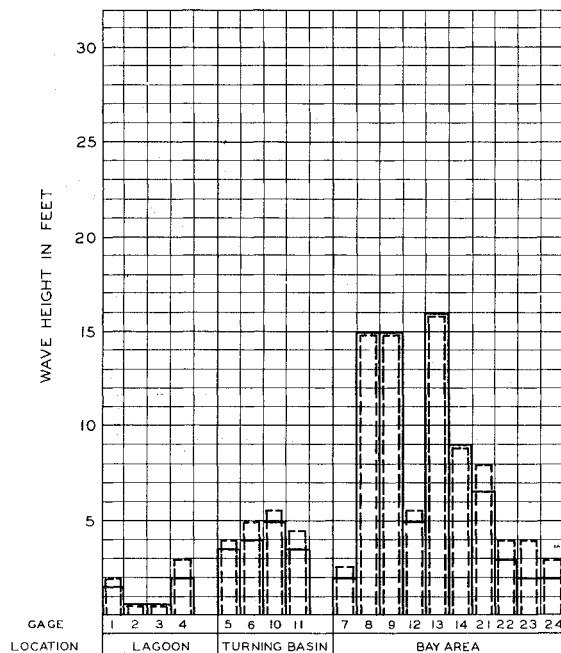
MODEL STUDY OF BREAKWATER LOCATION
U.S. NAVAL AIR STATION
ALAMEDA, CALIFORNIA

COMPARISON OF WAVE HEIGHTS
BASE TEST, PLAN 18B, PLAN 18G

WAVES FROM SOUTH

NOTE: TOP ELEVATION OF BREAKWATER IS +17.0 FEET, MEAN LOWER LOW WATER.

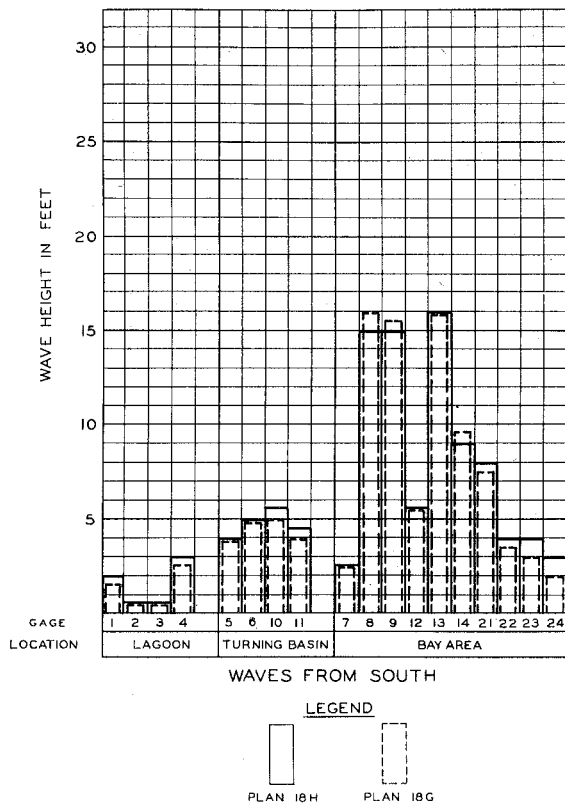
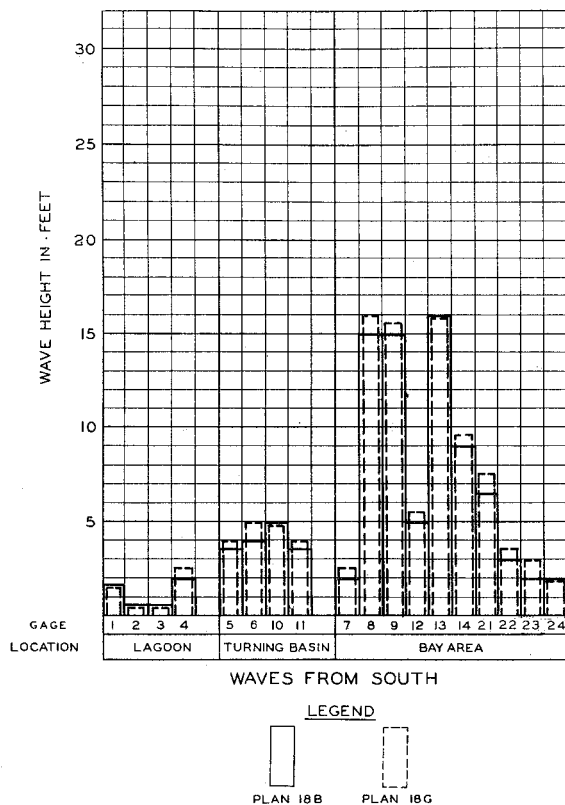
MODEL STUDY OF BREAKWATER LOCATION
 U.S. NAVAL AIR STATION
 ALAMEDA, CALIFORNIA

**COMPARISON OF WAVE HEIGHTS
 BASE TEST, PLAN 18B, PLAN 18H**

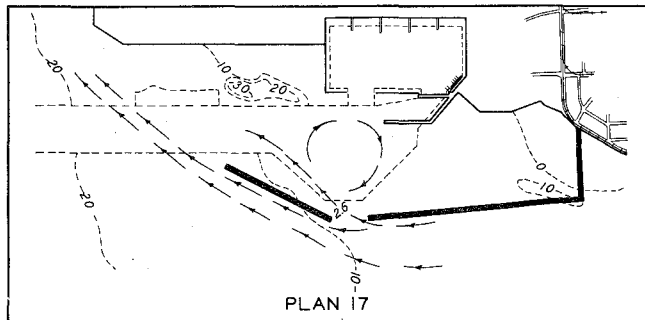
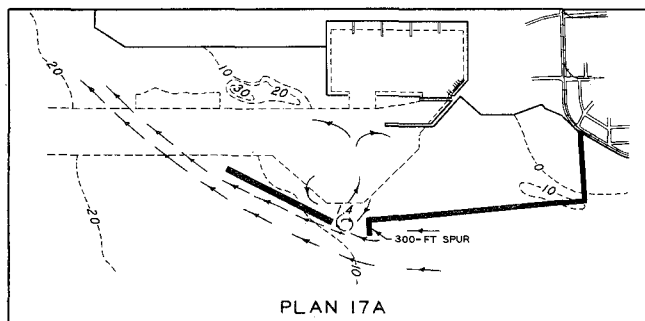
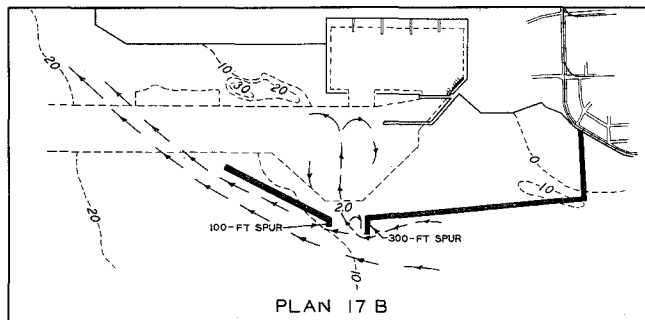
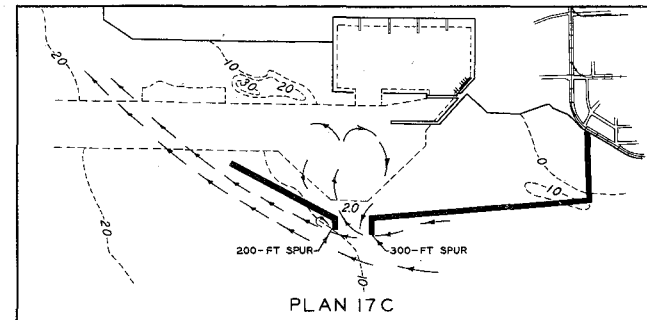
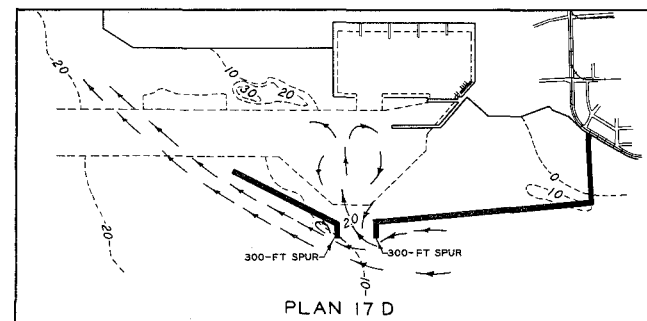
- BREAKWATER LOCATIONS
- 2.6 EBB TIDE CURRENT - FEET PER SECOND PROTOTYPE

NOTE: WIDTH OF NAVIGATION OPENING EQUALS 750 FT.
CURRENT DIRECTION AND MAGNITUDE MEASURED
WITHOUT WAVE ACTION.

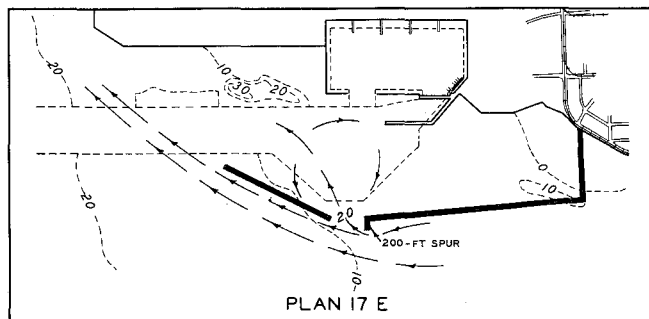
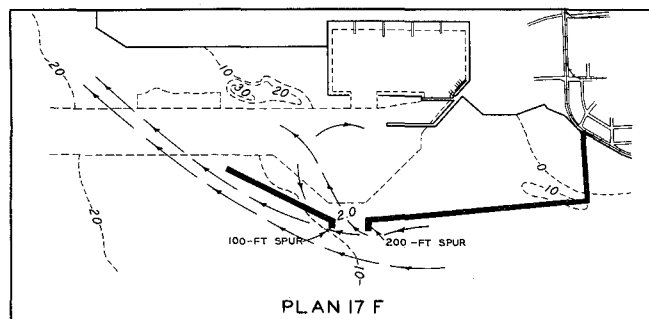
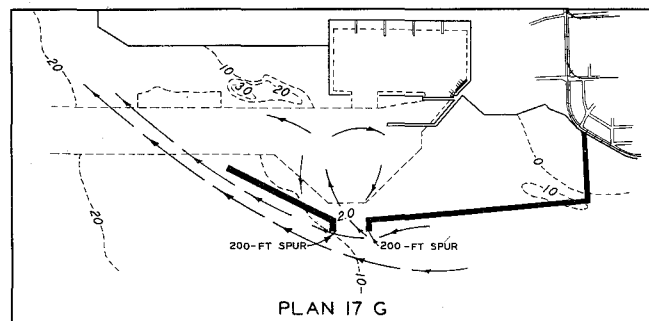
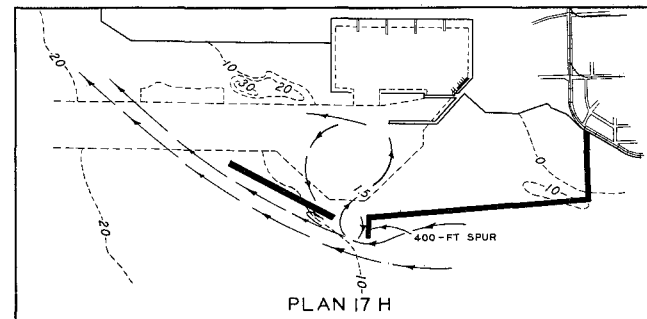
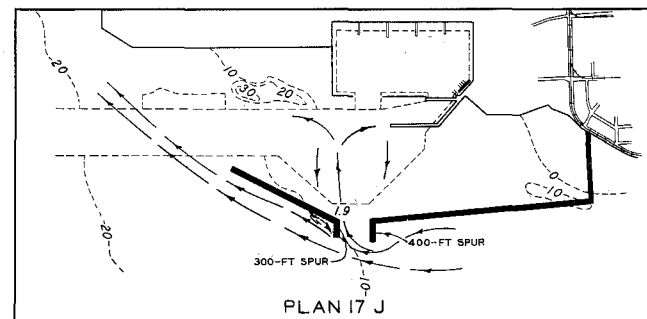
- BREAKWATER LOCATIONS
- EBB TIDE CURRENT - FEET PER SECOND PROTOTYPE

NOTE: WIDTH OF NAVIGATION OPENING EQUALS 750 FT.
CURRENT DIRECTION AND MAGNITUDE MEASURED
WITHOUT WAVE ACTION.
